FACILITY STATUS CHANGE FORM

Date Submitted: February 20, 2014 Originator: Chris Strand Phone: 554-2720	Area: 300 Area Facility ID: 340 Action Memorandum: Action Memorandum #3	Control #: D4-300-096
--	---	---------------------------------

340 Waste Neutralization Facility

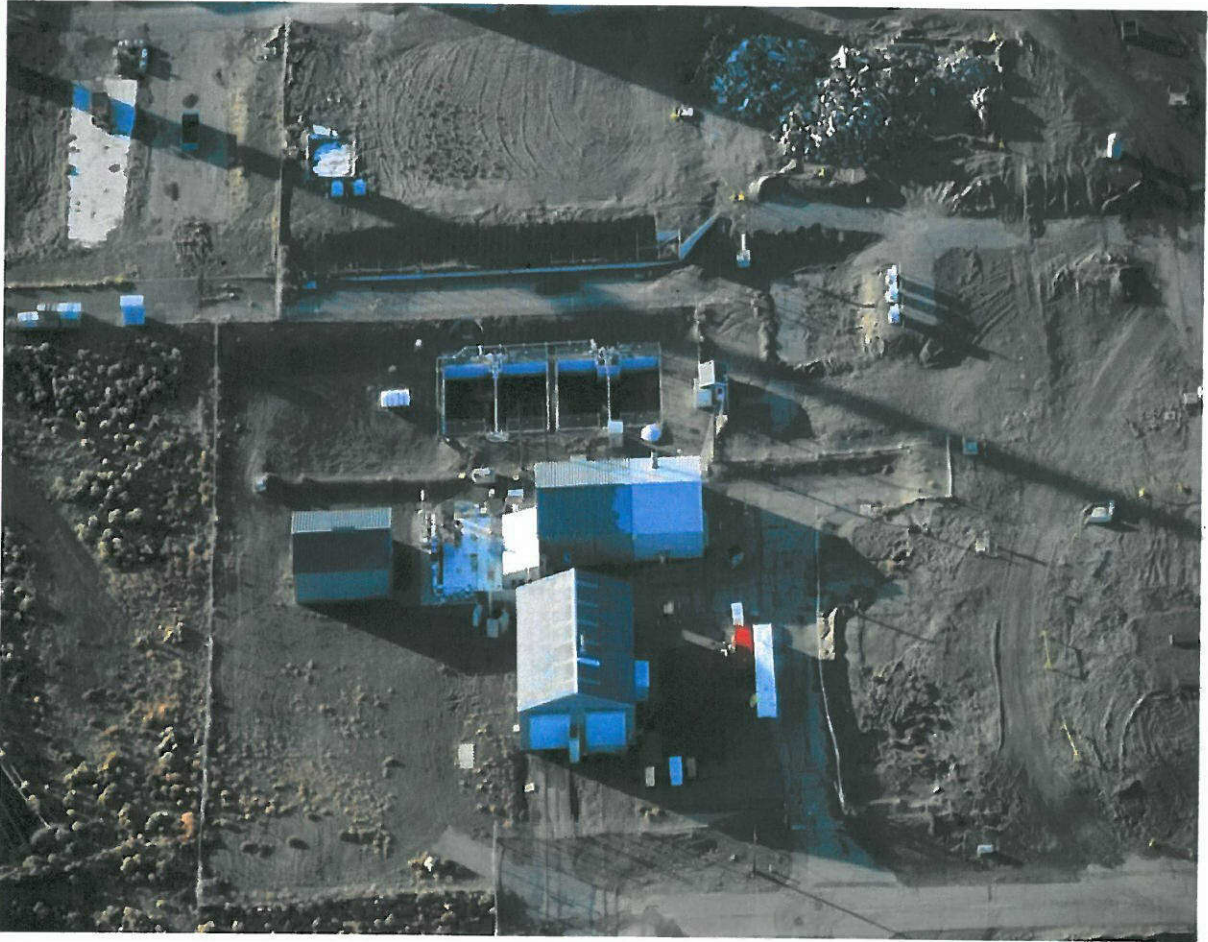
Photograph 1: Aerial photograph of the 340 Complex, looking south on October 22, 2009.

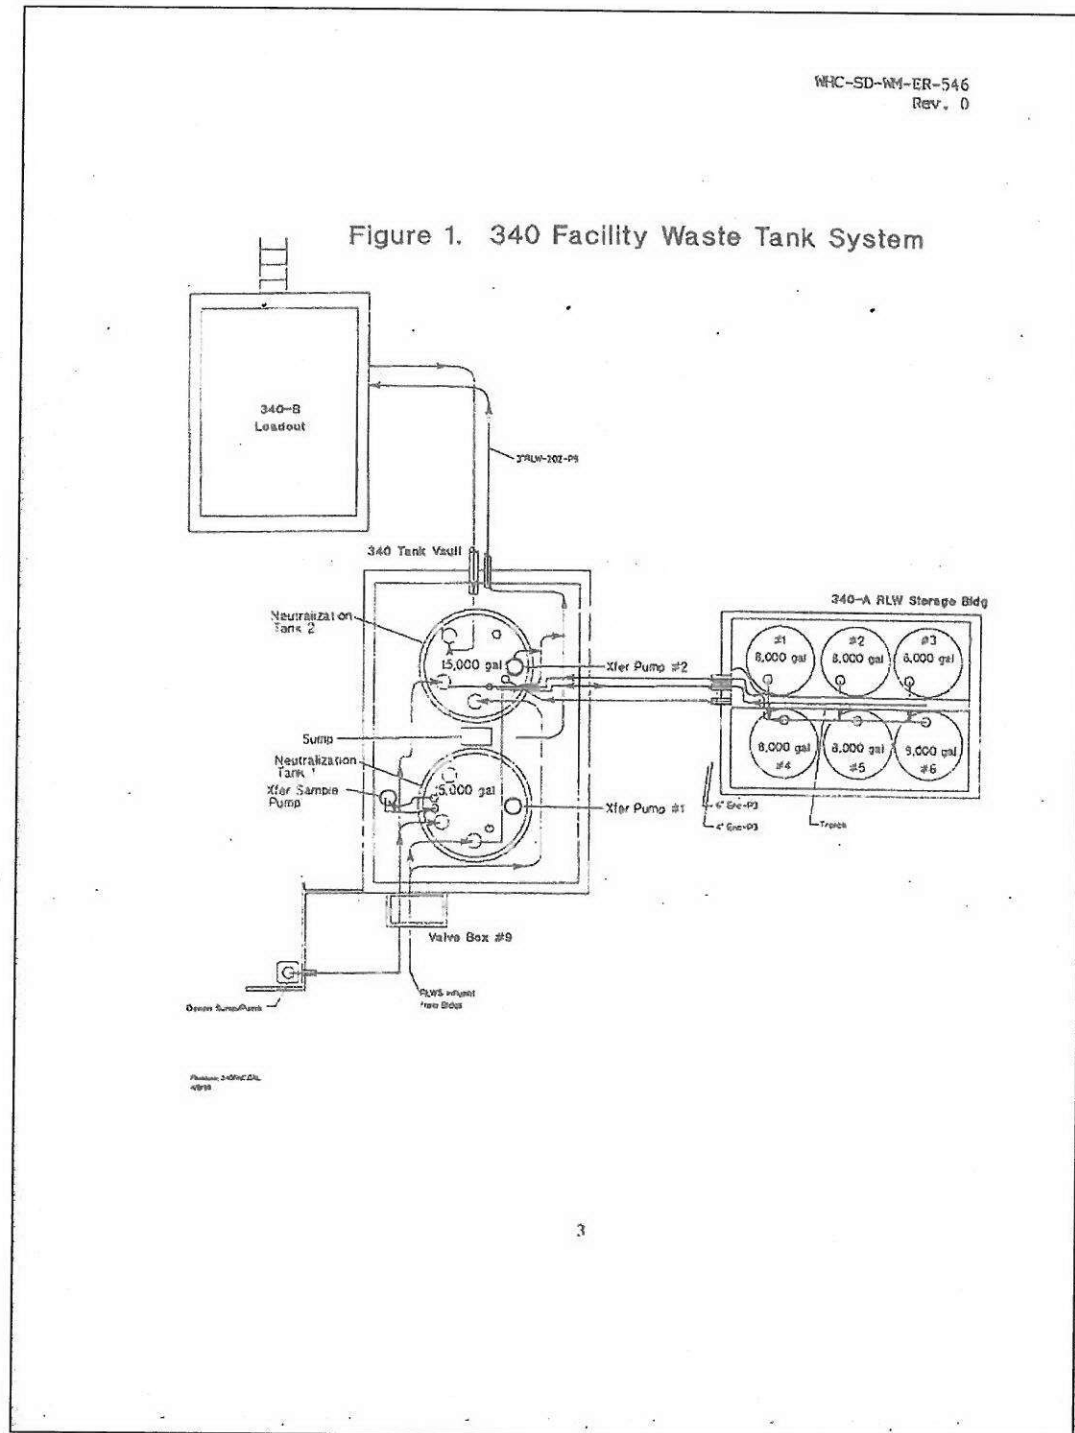
Figure 1: 340 Complex tank system layout showing relation of the 340 vault to other complex facilities.

The concrete vault that enclosed the two tanks was 38 by 25 by 25 ft with removable shielding cover blocks and access holes. The two tanks within the vault were of a nominal 15,000 gallon capacity each and were serviced by a network of piping that connected the 340 facility with upstream generating laboratories and the 307 retention basins. Above-grade penthouses allowed controlled entry to the tank vault and the associated valve pit. The vault and vault tanks had a common exhaust system that discharged through two-stage HEPA filters and two exhaust fans. Charcoal filters were later added to control the potential Iodine-131 releases.

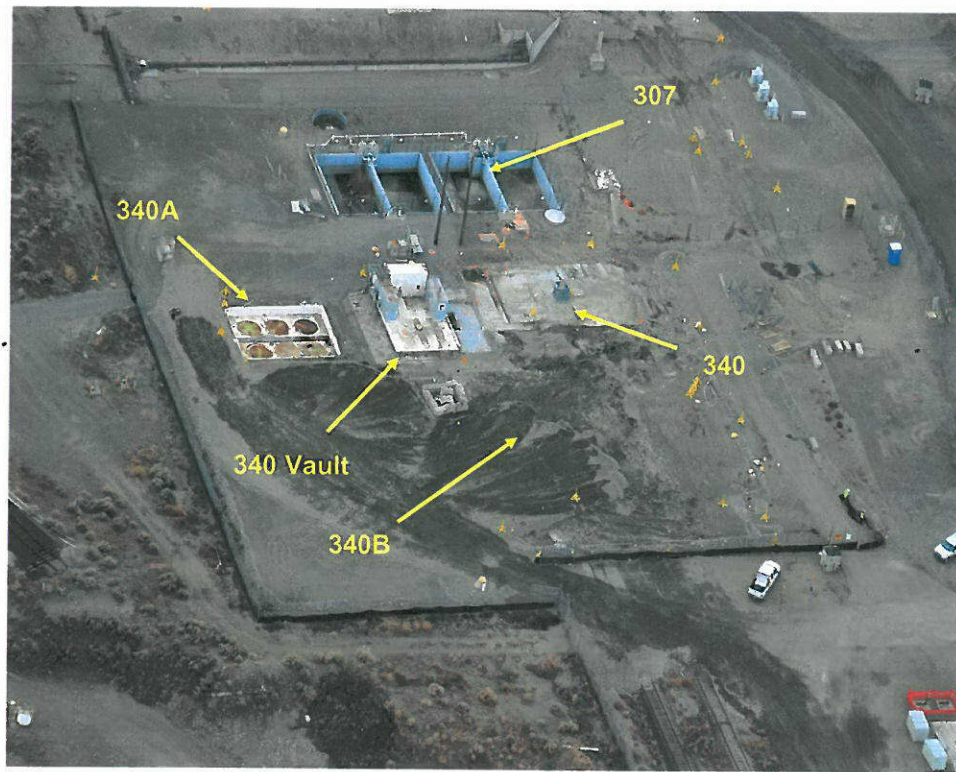
Photograph 2: Aerial photograph of the 340 Complex following above-grade demolition, looking southeast in October 2012.

Demolition of the 340 above-grade structure was completed in November 2011. Demolition of the below-grade structures was completed with removal of the 340 vault in February of 2014. The debris was removed and disposed of at ERDF.

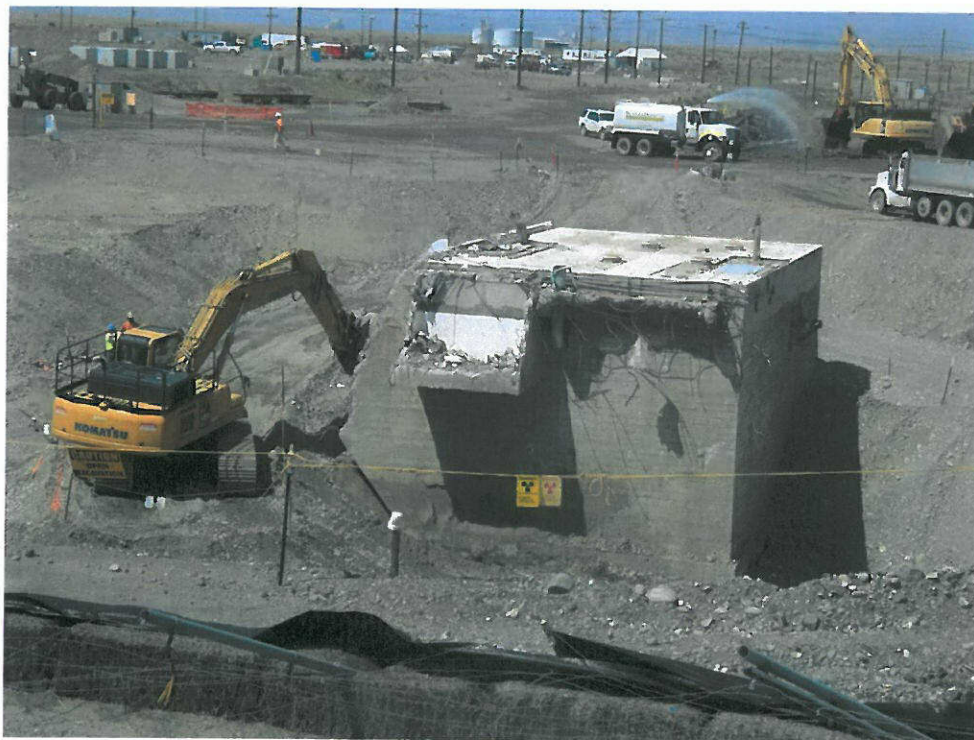
Photograph 3: 340 Vault during remediation excavation looking north on July 17, 2012

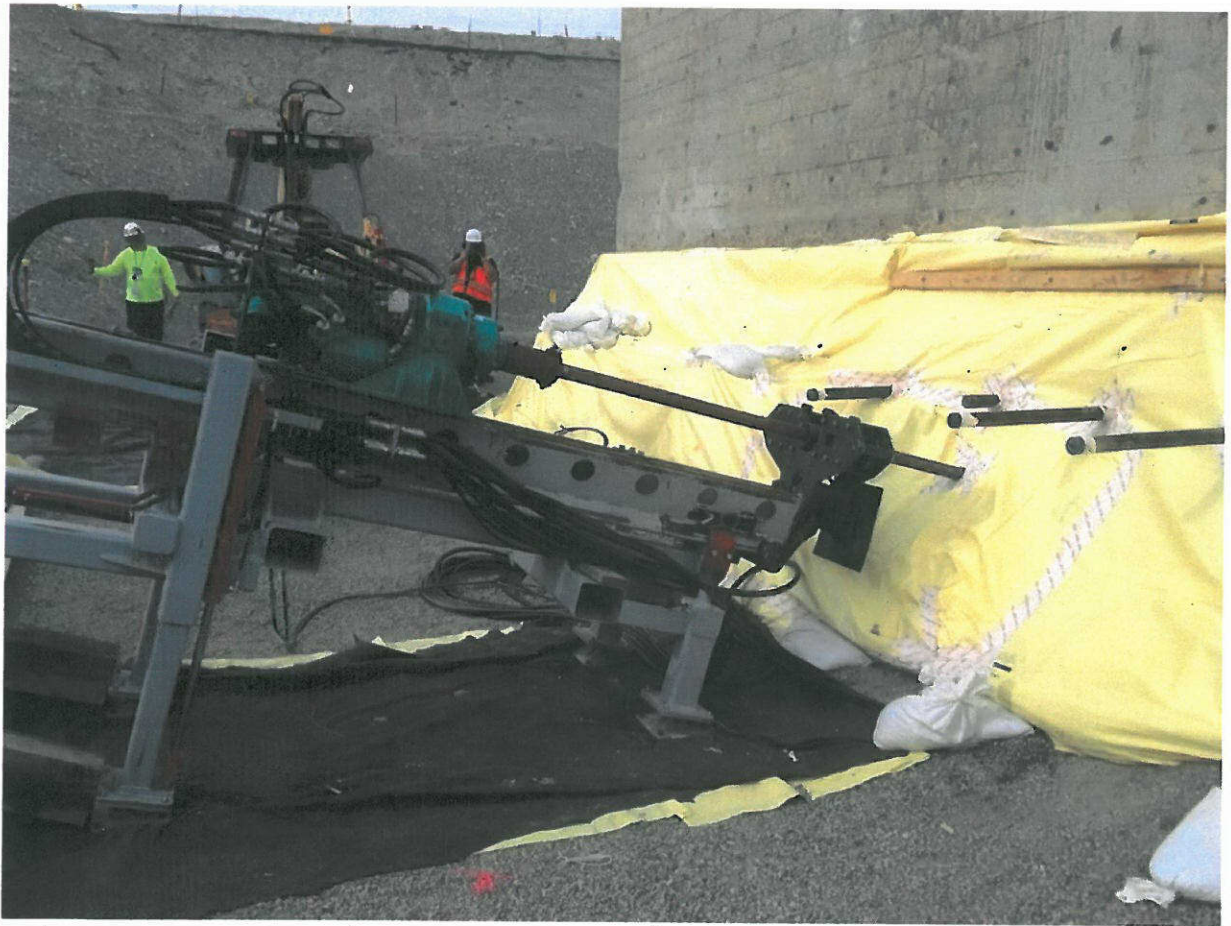
Photograph 4: Geo-Probe placement beneath vault, looking south on May 16, 2013.

Following discovery of highly contaminated soils beneath the 340 vault (reference Anomalies section below), an additional six (6) direct push environmental investigation wells were installed underneath the vault. Four were installed horizontally and two were installed at a 7.5 degree and 15 degree angle respectively. Radiological instruments were then inserted to measure dose and verify the spatial extent of the contaminated soil.

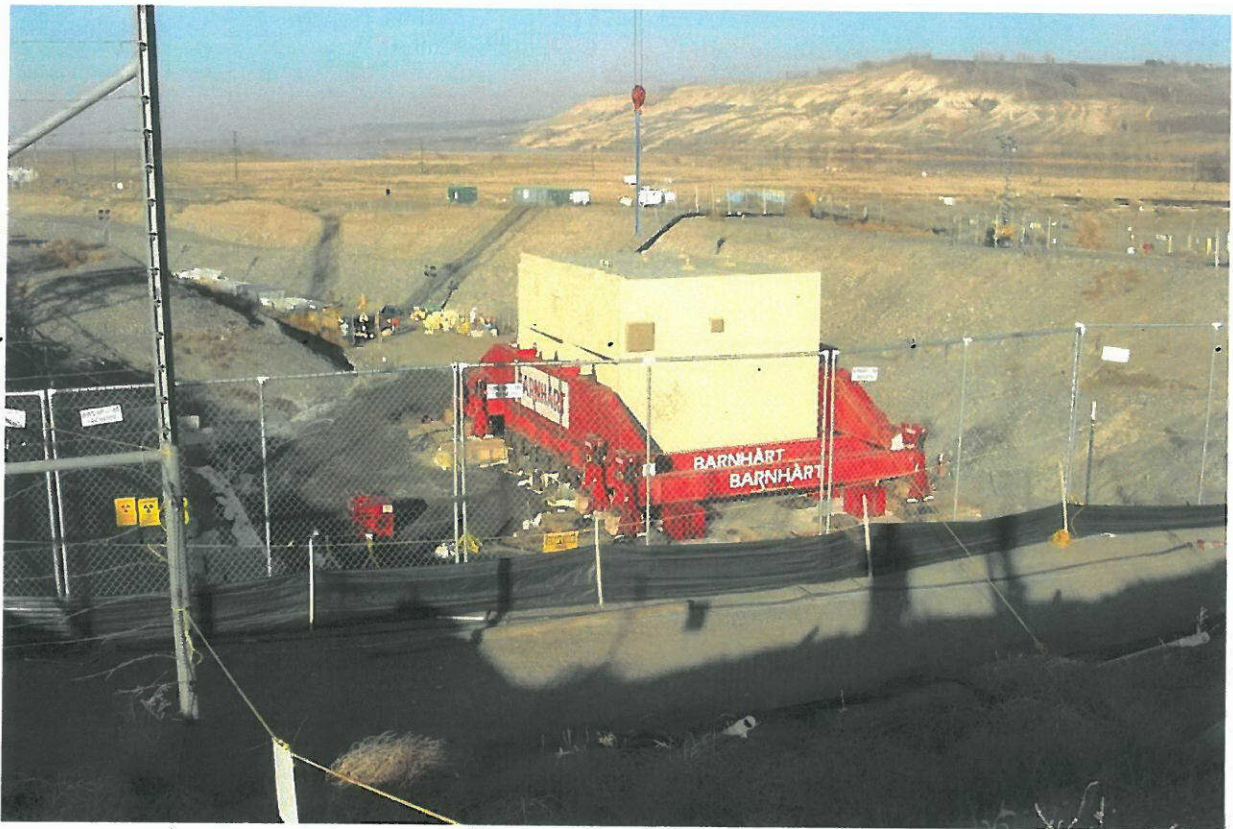
Photograph 5: 340 Vault on lift assembly, looking northeast on January 16, 2014.

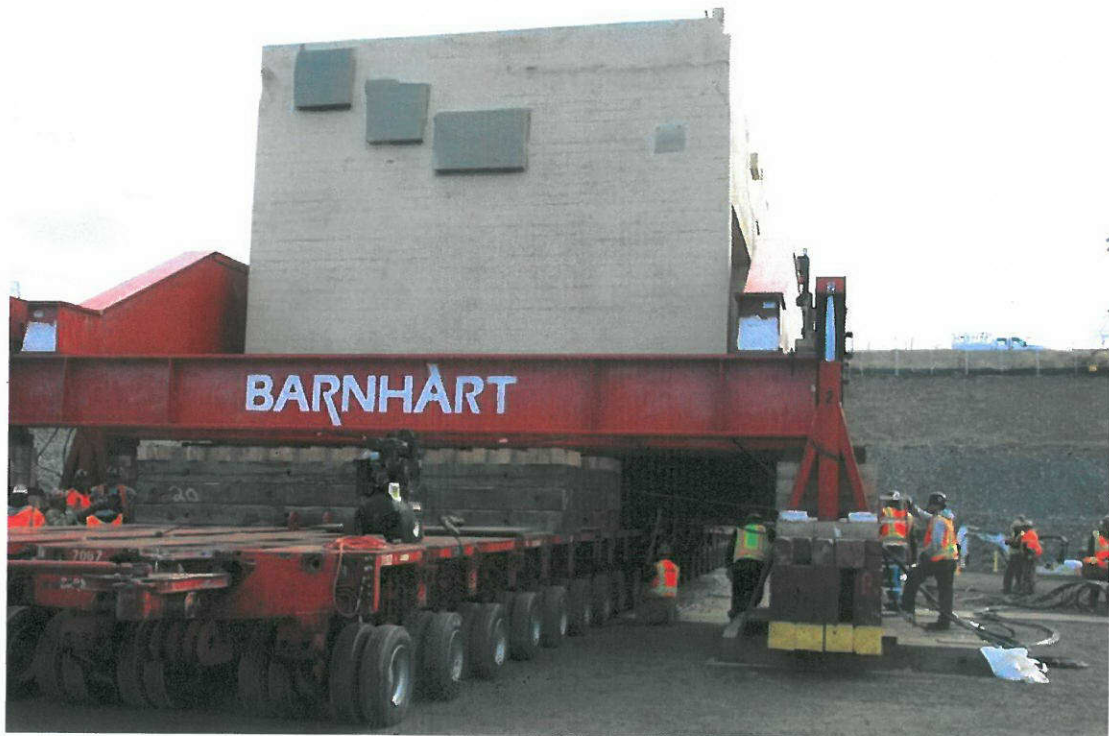
Photograph 6: 340 Vault during loading on the transport trailer, looking south on January 31, 2014

Above-grade demolition of the 340 Waste Handling Facility was completed in November 2011. Below-grade demolition, including vault (with tanks) removal was completed in February of 2014. Specifically, the vault was transported out of the excavation on February 13, 2014.

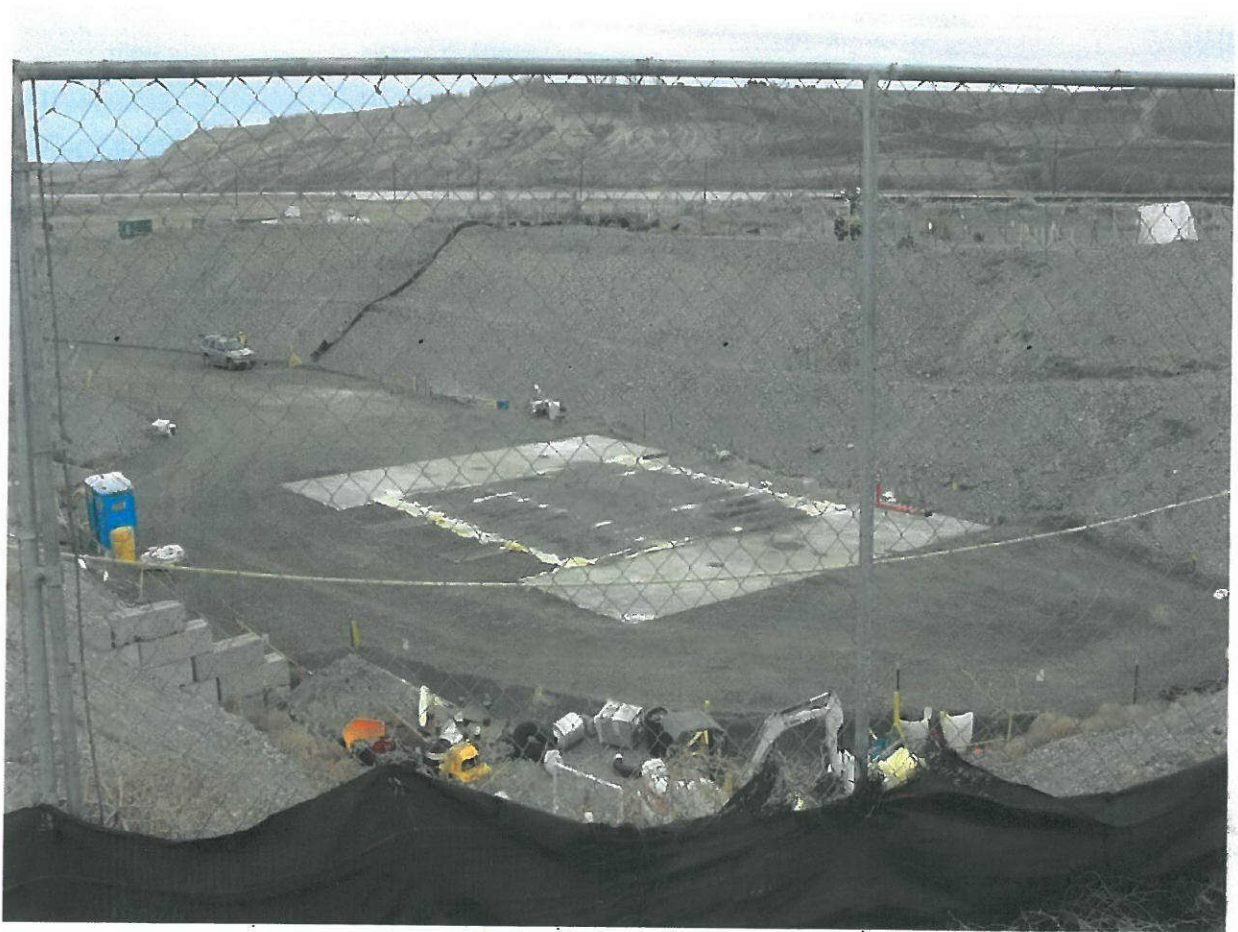
Photograph 7: 340 Vault excavation following vault transport to ERDF, looking northeast on February 18, 2014

The excavation remains open and radiologically posted as remediation of 340 Complex waste sites continue. No GPERS surveys were conducted as close-out surveys and verification sampling will be performed in accordance with the 300-FF-2 Final Action ROD.
